## SINGLE SURVEY REPORT

PROPERTY ADDRESS	47 Cornhill Terrace Edinburgh EH6 8EJ
CLIENT	Claire Carpenter
CLIENT ADDRESS	c/o Avenue Road Edinburgh
DATE OF INSPECTION	20 <sup>th</sup> October 2020
PREPARED BY	DIXON HEANEY KEAN KENNEDY Chartered Surveyors 54 Corstorphine Road Edinburgh EH12 6JQ Tel: 0131 313 0444 Fax: 0131 313 0555 Email: <a href="mailto:survey@dhkk.co.uk">survey@dhkk.co.uk</a>

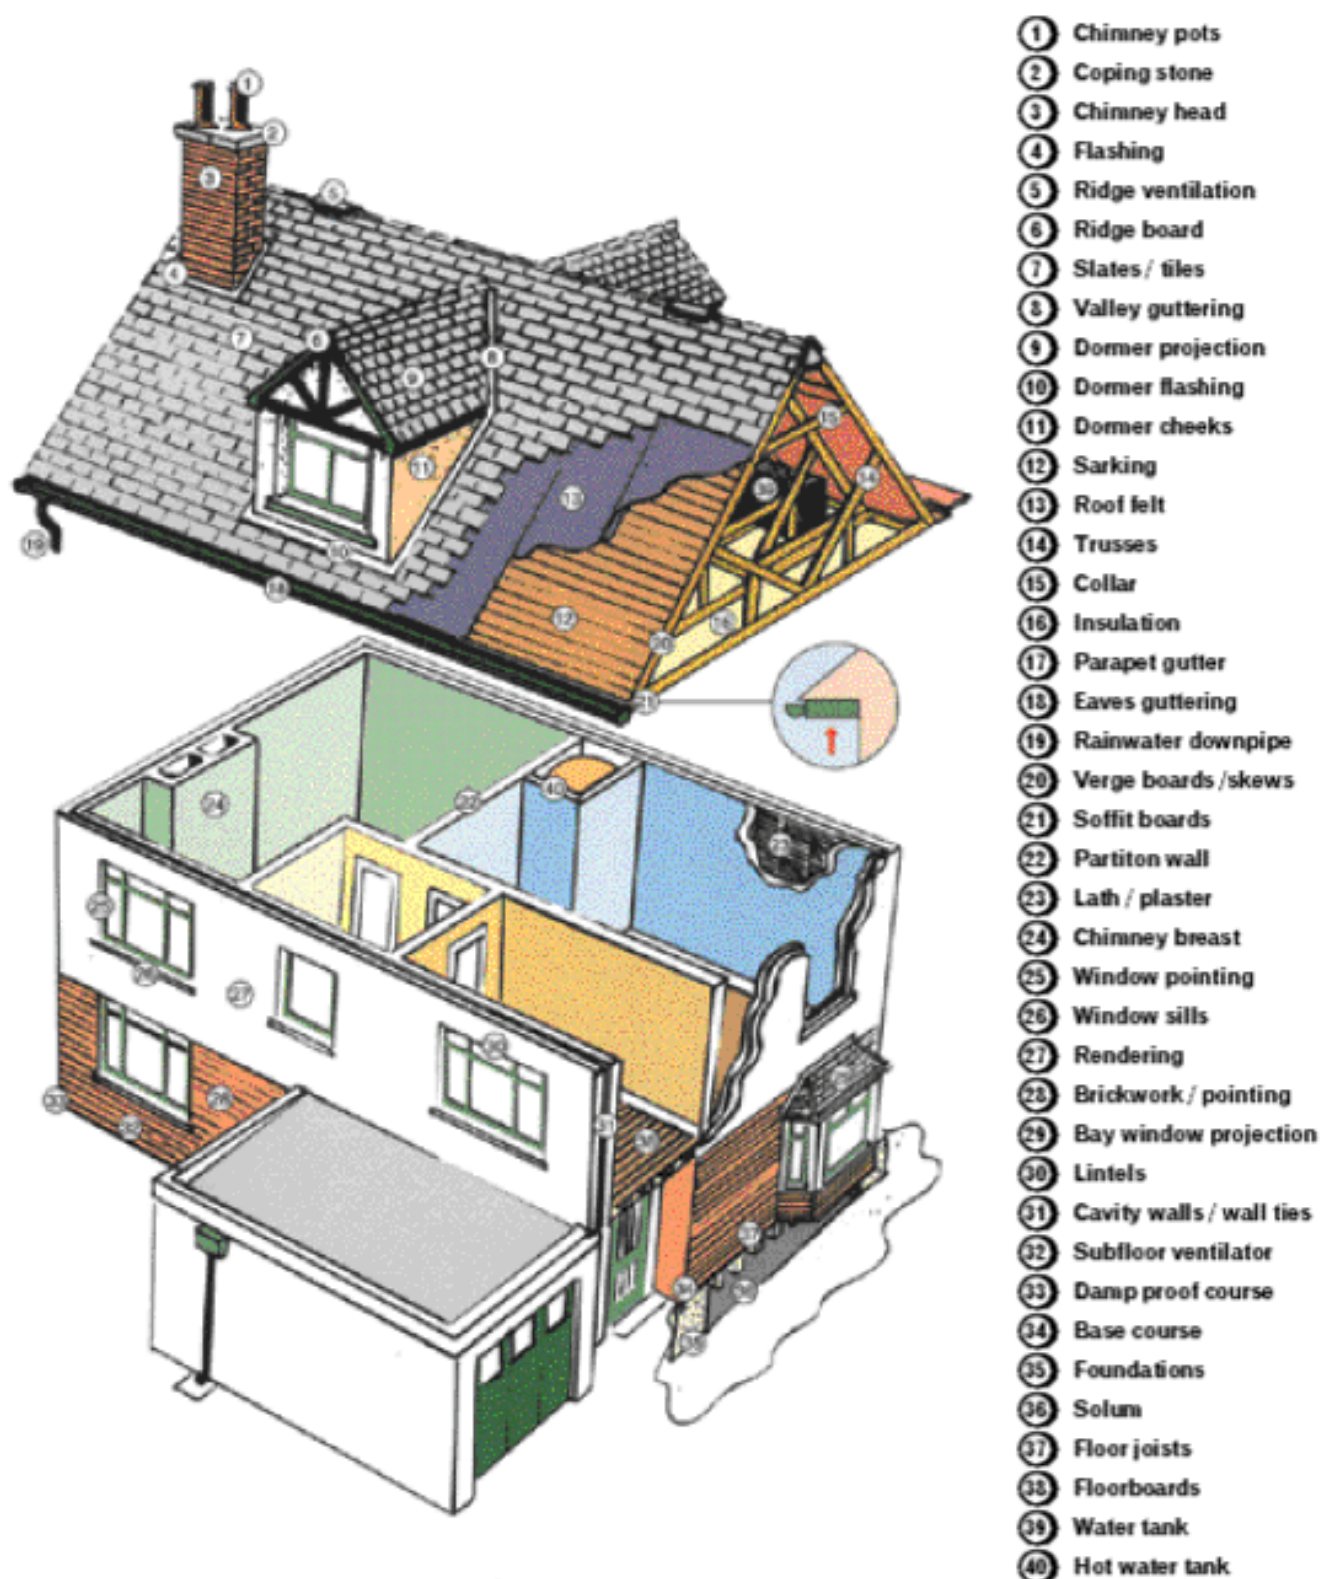
## Sectional diagram showing elements of a typical house

Reference may be made in this report to some or all of the above component parts of the property. This diagram may assist you in locating and understanding these terms.
