HOME REPORT

136 STRATHBEG DRIVE
DALGETY BAY
DUNFERMLINE
KY11 9XH

ENERGY PERFORMANCE CERTIFICATE

Dwelling type: Detached house
Date of assessment: 16 May 2024
Date of certificate: 16 May 2024
Total floor area: 92 m²
Primary Energy Indicator: 196 kWh/m²/year

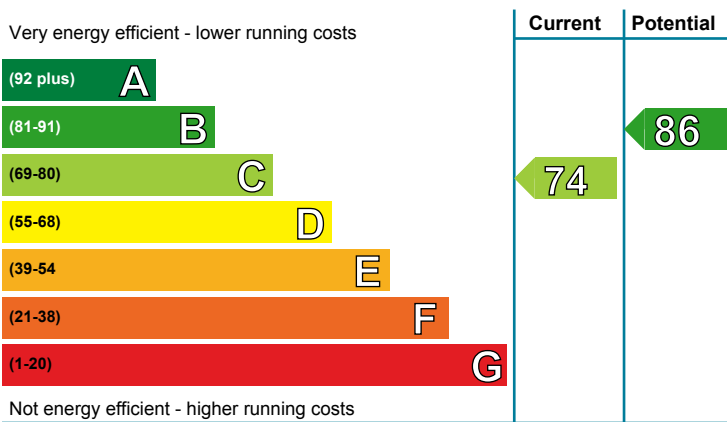
Energy Efficiency Rating

This graph shows the current efficiency of your home, taking into account both energy efficiency and fuel costs. The higher this rating, the lower your fuel bills are likely to be.

Your current rating is **band C (74)**. The average rating for EPCs in Scotland is **band D (61)**.

The potential rating shows the effect of undertaking all of the improvement measures listed within your recommendations report.
