HOME REPORT

15 LIXMOUNT AVENUE
TRINITY
EDINBURGH
EH5 3EW

Energy Performance Certificate (EPC)

Single Survey

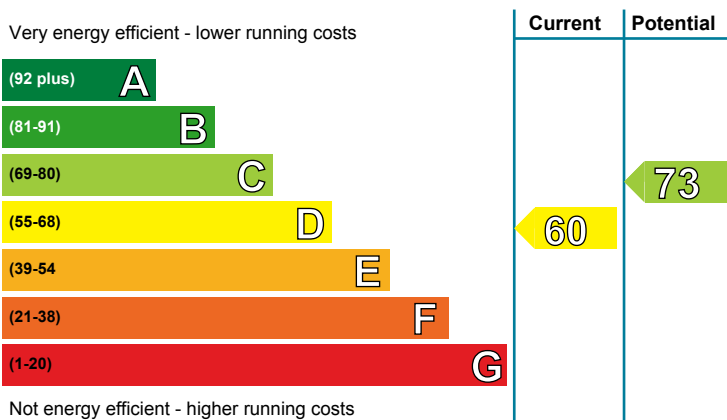
Energy Efficiency Rating

This graph shows the current efficiency of your home, taking into account both energy efficiency and fuel costs. The higher this rating, the lower your fuel bills are likely to be.

Your current rating is **band D (60)**. The average rating for EPCs in Scotland is **band D (61)**.

The potential rating shows the effect of undertaking all of the improvement measures listed within your recommendations report.
