Single Survey

Property Address	56 Kingston Avenue Edinburgh Midlothian EH16 5SW
Customer	AMG
Date of Inspection	22/10/2025
Prepared by	N Ogg Connells Survey & Valuation Ltd

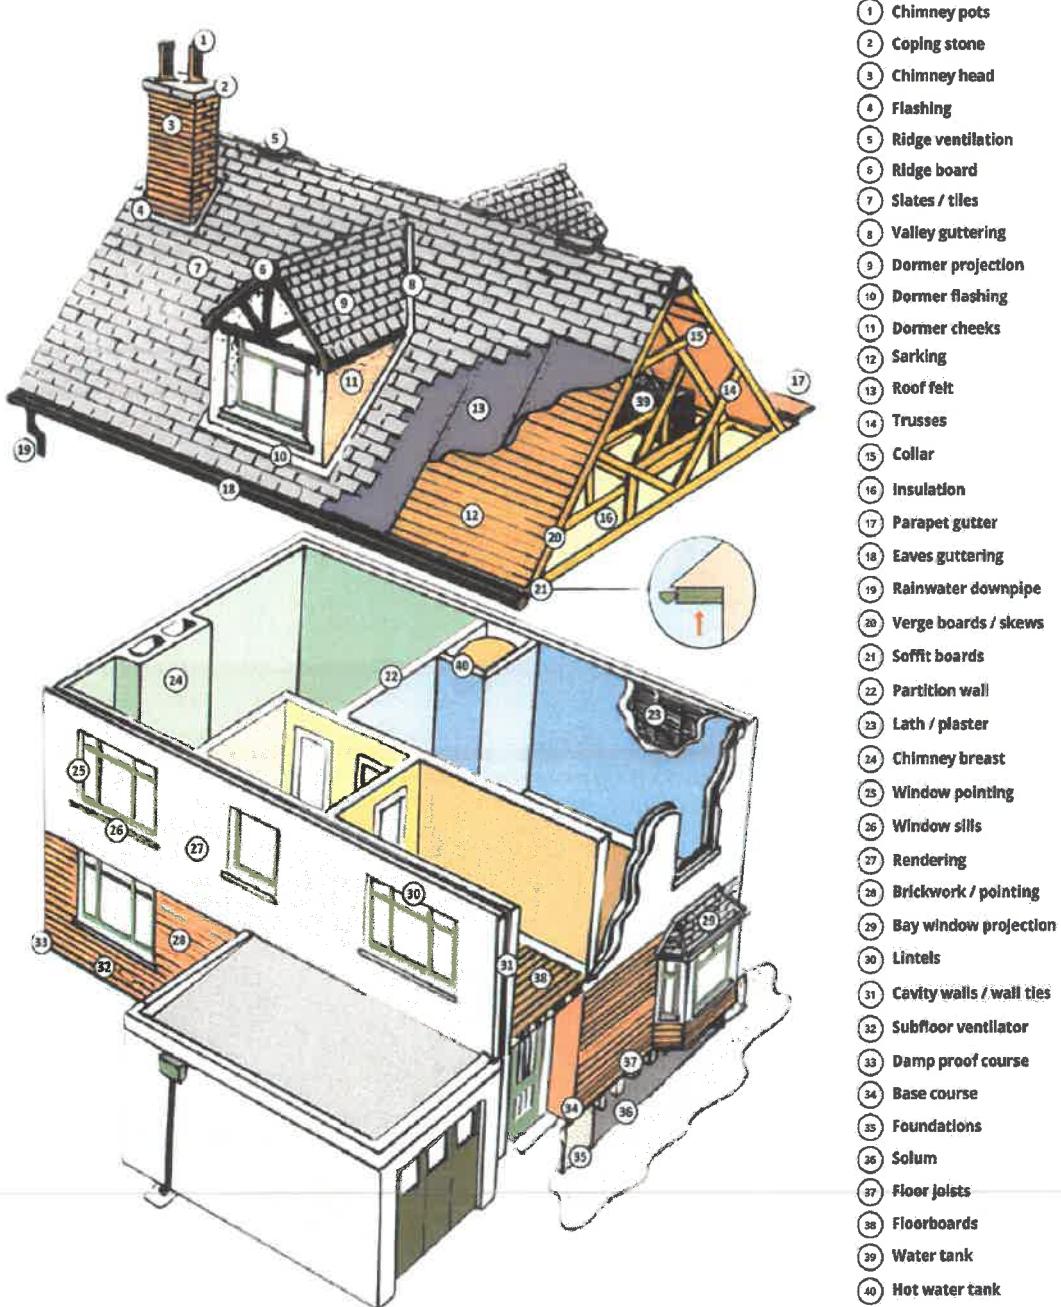
Sectional Diagram showing elements of a typical house

Reference may be made in this report to some or all of the above component parts of the property. This diagram may assist you in locating and understanding these items.
