HOME REPORT

44 OXGANGS ROAD NORTH
OXGANGS
EDINBURGH
EH13 9DR

survey report on:

Property address	44 OXGANGS ROAD NORTH, OXGANGS, EDINBURGH, EH13 9DR
Customer	JON & MAGGIE REID
Customer address	
Prepared by	DM Hall LLP
Date of inspection	20th May 2024

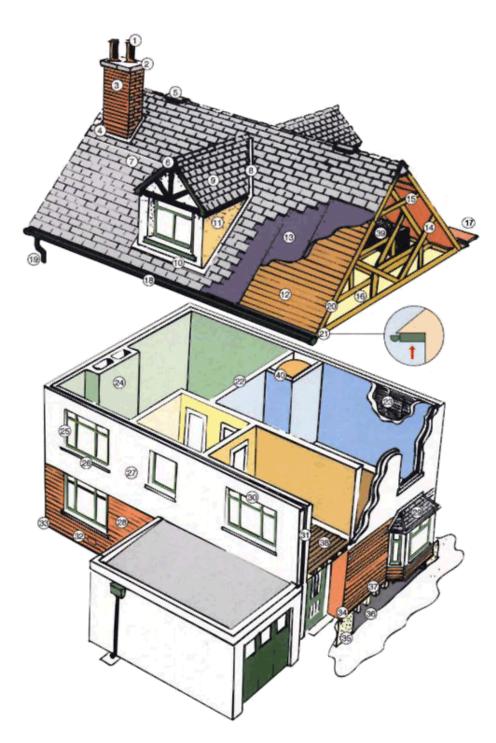
Sectional Diagram showing elements of a typical house

Reference may be made in this report to some or all of the above component parts of the property. This diagram may assist you in locating and understanding these items.

- 1) Chimney pots
- 2 Coping stone
- 3) Chimney head
- 4 Flashing
- 5 Ridge ventilation
- 6) Ridge board
- 7) Slates / tiles
- 8 Valley guttering
- 9 Dormer projection
- 10) Dormer flashing
- 11) Dormer cheeks
- (12) Sarking
- (13) Roof felt
- (14) Trusses
- (15) Collar
- (16) Insulation
- (17) Parapet gutter
- 18) Eaves guttering
- Rainwater downpipe
- 20) Verge boards /skews
- 21) Soffit boards
- 22) Partition wall
- 23) Lath / plaster
- (24) Chimney breast
- (25) Window pointing
 - 6) Window sills
- 27) Rendering
- (28) Brickwork / pointing
- 29) Bay window projection
- 30 Lintels
- (31) Cavity walls / wall ties
- 32) Subfloor ventilator
- 33) Damp proof course
- 34) Base course
- 35) Foundations
- 36) Solum
- Floor joists
- 38) Floorboards
- 39) Water tank
- 40 Hot water tank
