HOME REPORT

147 BIRKENSIDE
GOREBRIDGE
EH23 4JH

ENERGY PERFORMANCE CERTIFICATE

Single Survey

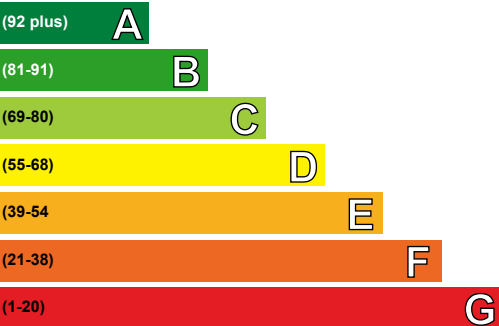
Energy Efficiency Rating

Current	Potential
73	77

This graph shows the current efficiency of your home, taking into account both energy efficiency and fuel costs. The higher this rating, the lower your fuel bills are likely to be.

Your current rating is **band C (73)**. The average rating for EPCs in Scotland is **band D (61)**.

The potential rating shows the effect of undertaking all of the improvement measures listed within your recommendations report.

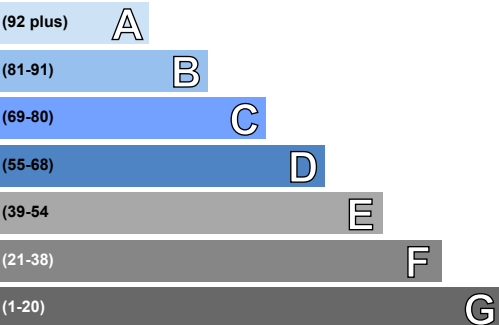
Current	Potential
74	79

The potential rating shows the effect of undertaking all of the improvement measures listed within your recommendations report.
