### survey report on:

Property address	52 Inchgarvie Avenue, Burntisland, KY3 0BU
Customer	Mr & Mrs Barr
	,
Customer address	
Prepared by	DHKK Chartered Surveyors
Date of inspection	25th July 2023

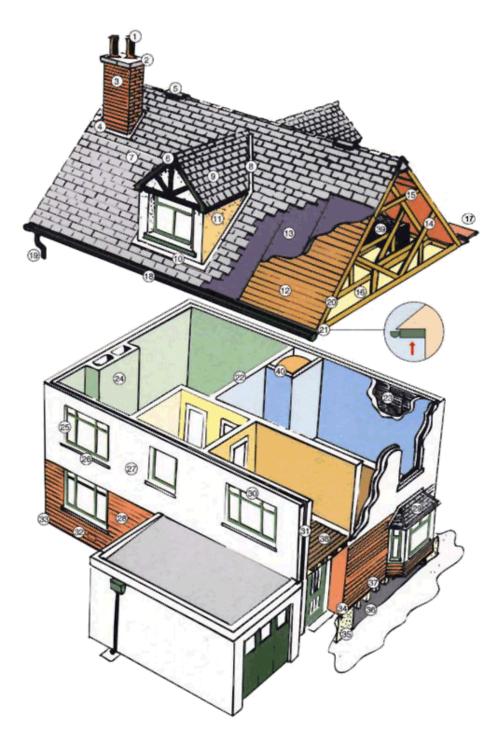
### Sectional Diagram showing elements of a typical house

Reference may be made in this report to some or all of the above component parts of the property. This diagram may assist you in locating and understanding these items.

- 1) Chimney pots
- 2 Coping stone
- 3) Chimney head
- 4 Flashing
- 5 Ridge ventilation
- 6 Ridge board
- 7) Slates / tiles
- 8 Valley guttering
- 9 Dormer projection
- 10) Dormer flashing
- 11) Dormer cheeks
- 12) Sarking
- (13) Roof felt
- (14) Trusses
- (15) Collar
- 16) Insulation
- (17) Parapet gutter
- 18) Eaves guttering
- Rainwater downpipe
- (20) Verge boards /skews
- 21) Soffit boards
- 22) Partition wall
- 23) Lath / plaster
- (24) Chimney breast
- 25) Window pointing
- 6) Window sills
- 27) Rendering
- (28) Brickwork / pointing
- 29 Bay window projection
- 30 Lintels
- (31) Cavity walls / wall ties
- 32) Subfloor ventilator
- 33) Damp proof course
- 34) Base course
- 35) Foundations
- (36) Solum
- 37) Floor joists
- 38) Floorboards
- 39) Water tank
- 40 Hot water tank
