Home Report

12B Bevan Road,
Mayfield,
EH22 5QE

Single Survey

Survey Report on:

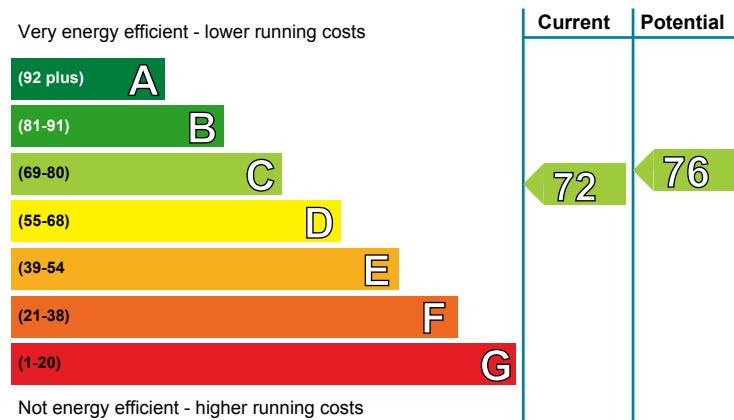
Energy Efficiency Rating

This graph shows the current efficiency of your home, taking into account both energy efficiency and fuel costs. The higher this rating, the lower your fuel bills are likely to be.

Your current rating is **band C (72)**. The average rating for EPCs in Scotland is **band D (61)**.

The potential rating shows the effect of undertaking all of the improvement measures listed within your recommendations report.

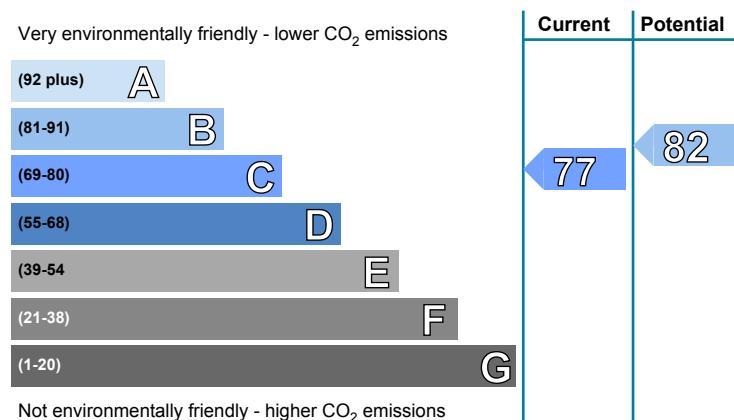
Environmental Impact (CO₂) Rating

This graph shows the effect of your home on the environment in terms of carbon dioxide (CO₂) emissions. The higher the rating, the less impact it has on the environment.
