HOME REPORT

4 EAST MAYFIELD
NEWINGTON
EDINBURGH
EH9 1SD

ENERGY PERFORMANCE CERTIFICATE

Single Survey

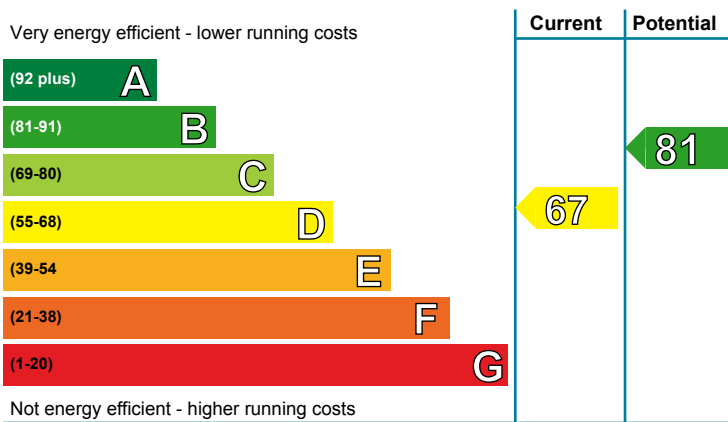
Energy Efficiency Rating

This graph shows the current efficiency of your home, taking into account both energy efficiency and fuel costs. The higher this rating, the lower your fuel bills are likely to be.

Your current rating is **band D (67)**. The average rating for EPCs in Scotland is **band D (61)**.

The potential rating shows the effect of undertaking all of the improvement measures listed within your recommendations report.
