HOME REPORT

76 HIGH STREET
LOANHEAD
EH20 9RR

Energy Performance Certificate (EPC)

Single Survey

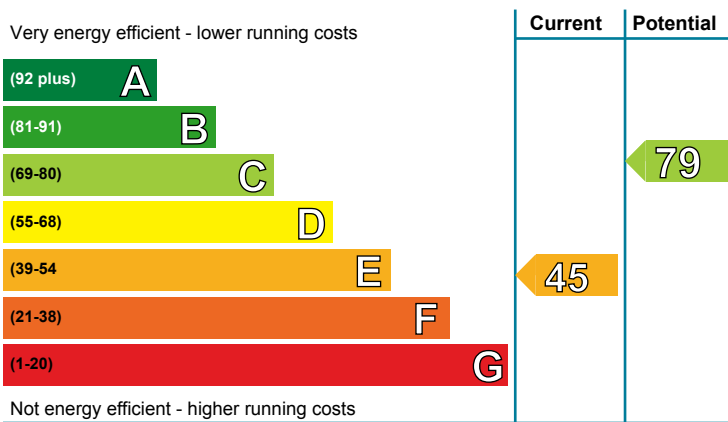
Energy Efficiency Rating

This graph shows the current efficiency of your home, taking into account both energy efficiency and fuel costs. The higher this rating, the lower your fuel bills are likely to be.

Your current rating is **band E (45)**. The average rating for EPCs in Scotland is **band D (61)**.

The potential rating shows the effect of undertaking all of the improvement measures listed within your recommendations report.

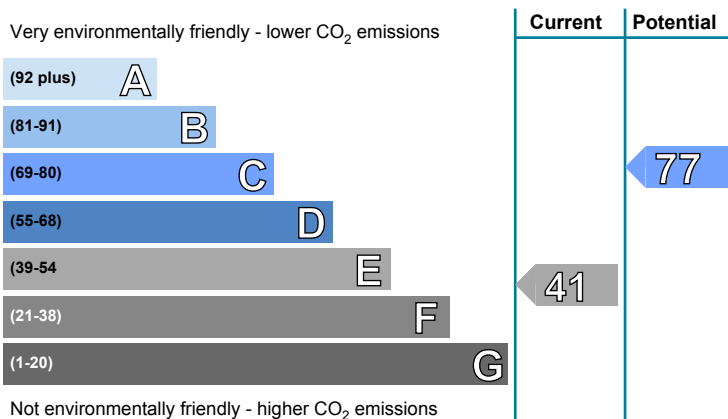
Environmental Impact (CO₂) Rating

This graph shows the effect of your home on the environment in terms of carbon dioxide (CO₂) emissions. The higher the rating, the less impact it has on the environment.

Your current rating is **band E (41)**. The average rating for EPCs in Scotland is **band D (59)**.

The potential rating shows the effect of undertaking all of the improvement measures listed within your recommendations report.
