HOME REPORT

60 PARK AVENUE
LOANHEAD
EH20 9BE

Energy Performance Certificate (EPC)

60 PARK AVENUE, LOANHEAD, EH20 9BE

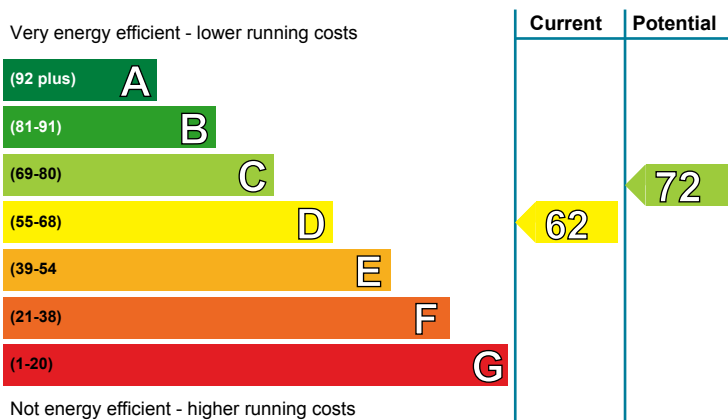
Energy Efficiency Rating

This graph shows the current efficiency of your home, taking into account both energy efficiency and fuel costs. The higher this rating, the lower your fuel bills are likely to be.

Your current rating is **band D (62)**. The average rating for EPCs in Scotland is **band D (61)**.

The potential rating shows the effect of undertaking all of the improvement measures listed within your recommendations report.
